CITY OF BALTIMORE WET WEATHER CONSENT DECREE SMOKE AND DYED WATER TESTING FORM		Page 1 of 4
Sewershed: Low Level Subsewershed: 44	Company: REI/DRAYCO	Date: 09/02/2008
Test Type: Smoke	Ground Condition: Dry: X Damp: _ Wet: _	Supervisor: E.R. Crew: 04
Manhole ID: S19O__008MH	Test ID: 1029-583	Notifications Made: __X__ Residents, Fire, 311
Field Sketch: (Show all manholes with numbers, blower placement location, sandbag or isolation locations, street names, building addresses and locations, defect locations and photograph numbers)

CITY OF BALTIMORE
SMOKE TESTING OBSERVATION SUMMARY
LOW LEVEL SEWERSHED
BALTIMORE CITY PROJECT 1029
REI/DRAYCO

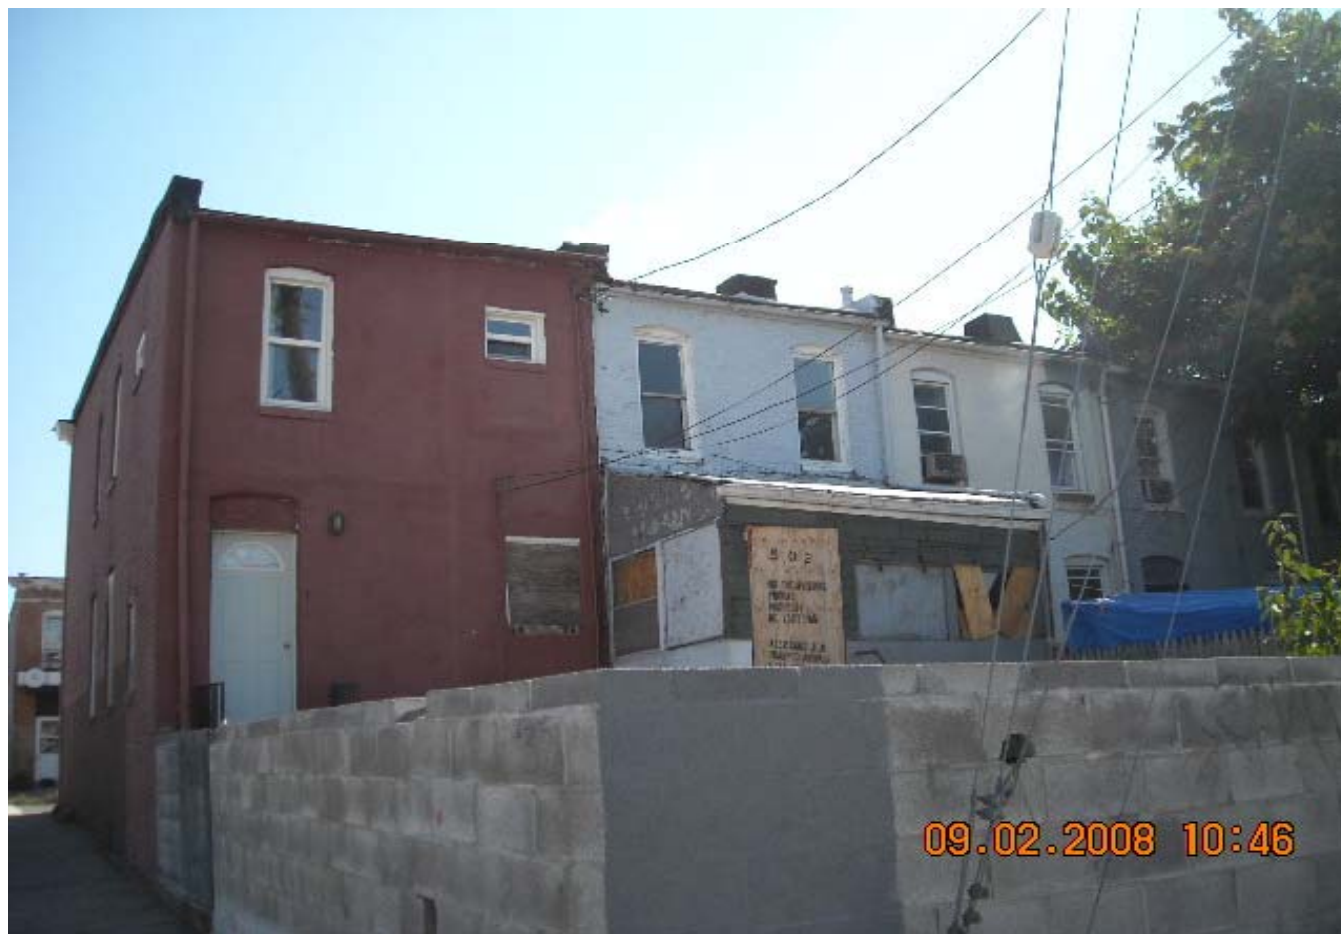
Photograph No: OB01-01
Filename: 1029-583_OB01-01.jpg

Unique Test ID: 583	Date: 09/02/2008	Basin: LL - 44	Manhole ID: S190__008MH
Defect No: OB01	Supervisor: E.R.	Crew: 04	Dye Test Recommended: N
Location: 502 S. BENTALOU ST.

Source Type: 18 Other

Sector: 02 Private

Location: 14 Other

Severity: 03 Moderate

Comments: THE SMOKING VENT HERE INDICATES THAT A SANITARY LINE EXISTS FROM S190__011MH TO THE END OF THE BLOCK, THAT IS NOT PICTURED ON MAP. OTHERWISE, THERE IS NO DEFECT.

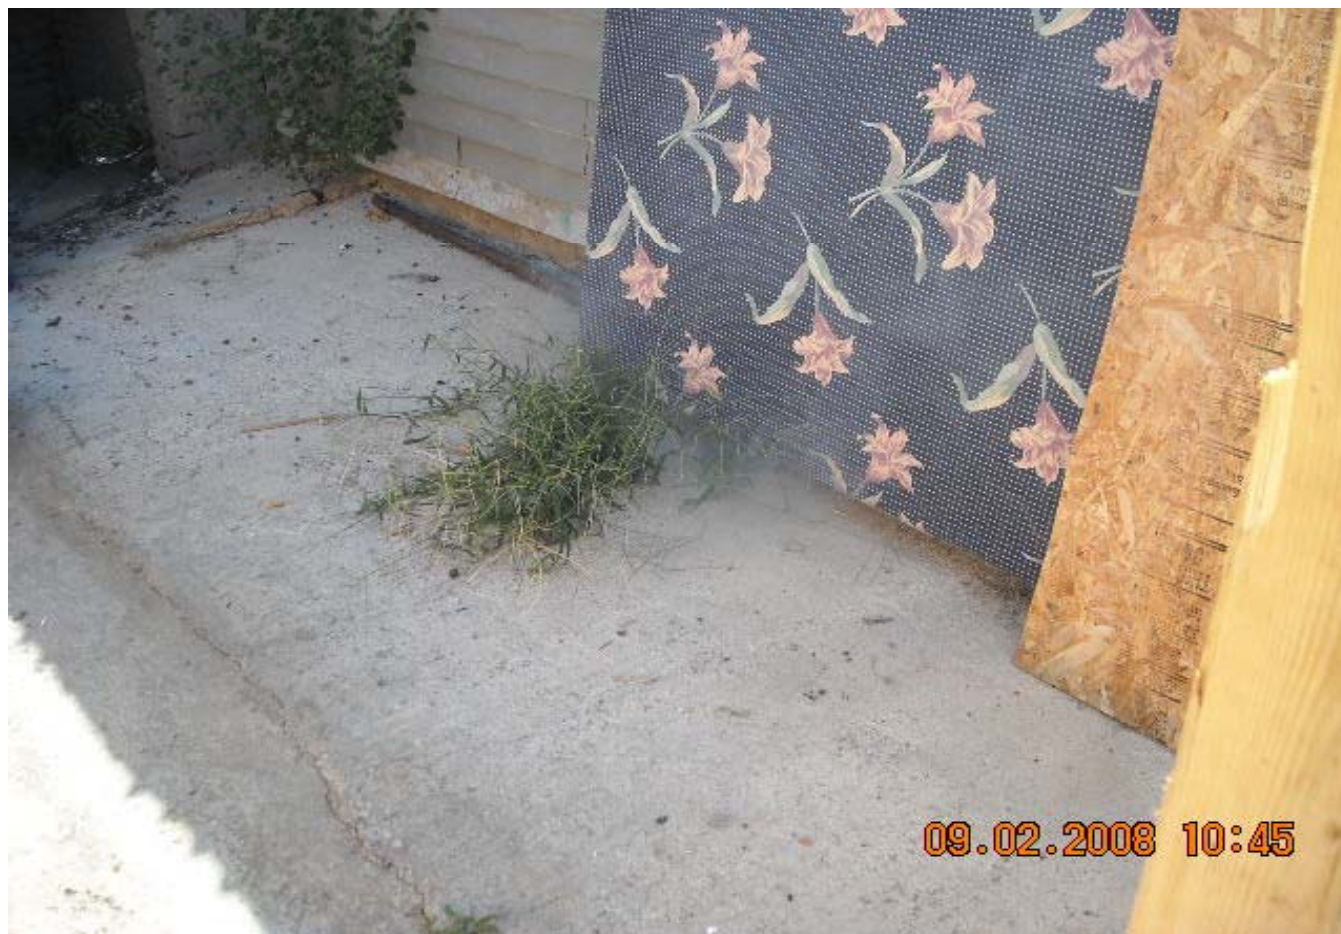
Photograph No: OB01-01
Filename: 1029-583_OB01-01.jpg

Unique Test ID: 583	Date: 09/02/2008	Basin: LL - 44	Manhole ID: S19O__008MH
Defect No: OB01	Supervisor: E.R.	Crew: 04	Dye Test Recommended: N
Location: 528 S. BENTALOU ST.			
Source Type: 18 Other	Sector: 02 Private		
Location: 14 Other	Severity: 03 Moderate	Drainage Area: 0	
Comments: SMOKE IS COMING FROM UNKNOWN DEFECT HIDDEN BY MATTRESSES AT ADDRESS.
